Melfields Farm or Plaindealing  
Near Chestertown  
c. 1857

GOOSE OVEN FARM  
Chestertown, Maryland  
(ca 1870)

## INVENTORY FORM FOR STATE HISTORIC SITES SURVEY

K-382 Melfields (Goose Oven Farm)

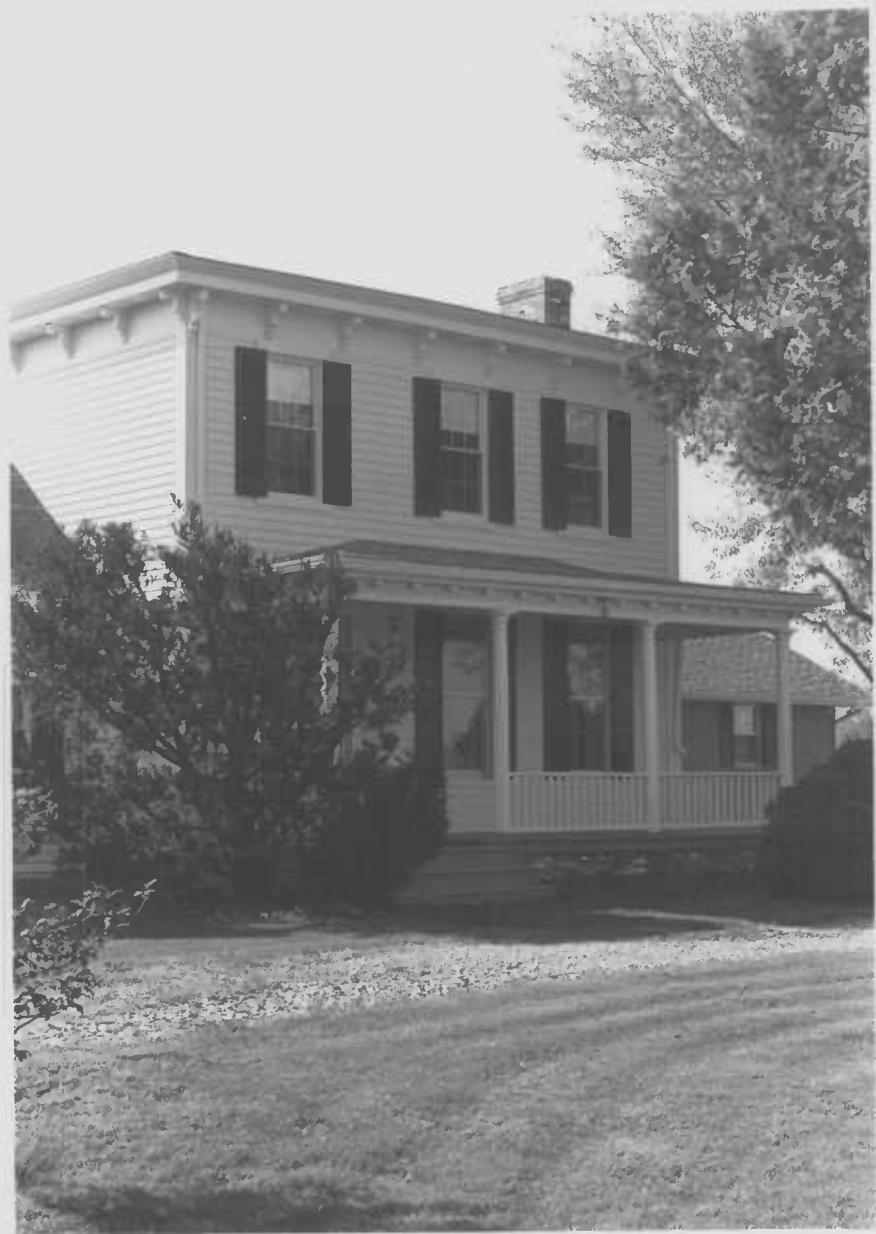
View to Southeast

Goose Oven is a mid-19th century frame structure which is a three-bay square in plan; it has a shallow hipped roof. Two stories in height, the building has a three-bay wide front porch and a gable-roof side wing which is  $\frac{1}{2}$  stories high and three bays in length. The main house is two rooms deep with a side hall plan; the wing is also two rooms deep and has a winder stair located in its south west corner. Despite their different forms architectural evidence indicates that the two portions of the building are contemporary.
